A Survey of Historic Sites in Rural Marion and Washington Counties, Kentucky

A Report on the Findings of the *Rural Heritage Development Initiative Survey*
A project funded by a National Park Service Preserve America Grant

Kentucky Heritage Council

The State Historic Preservation Office, 2009

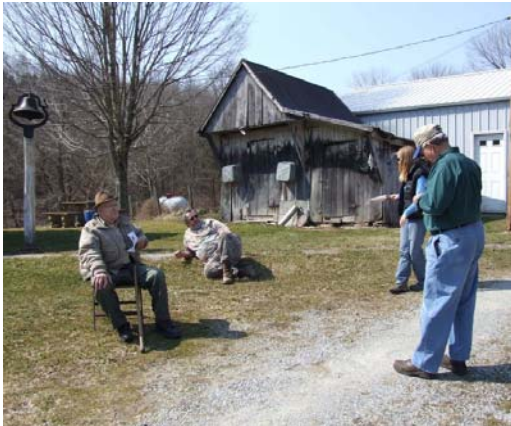
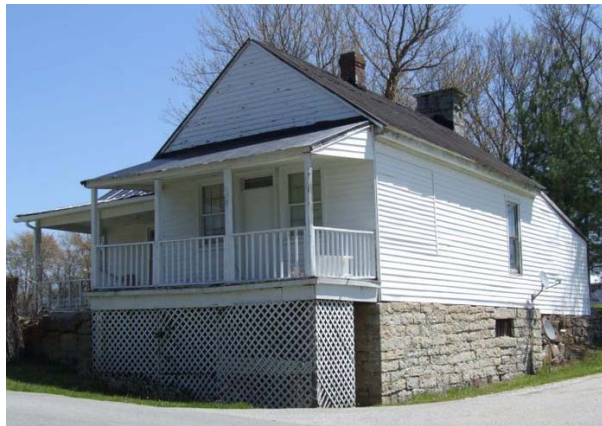
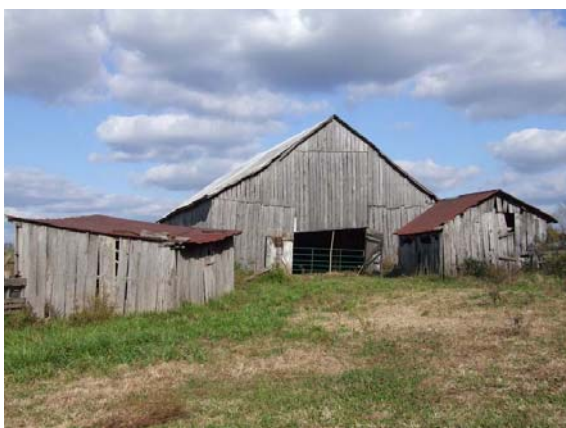
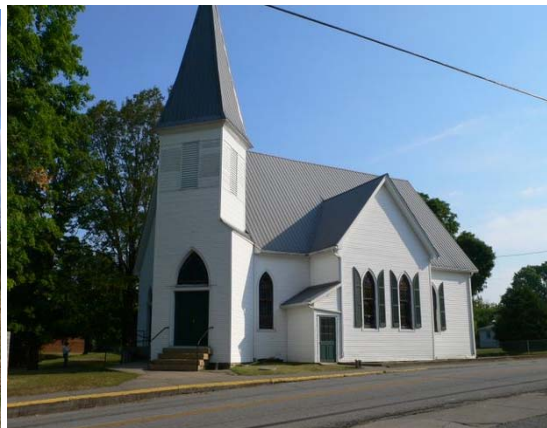
Cover: Top left: WS 630, John Best smoke house. Top right: MN 489, Bickett house/Raywick Jail. Bottom left: WS 95, barns. Bottom right: MN 926, Church/Bradfordsville Performing Arts Center

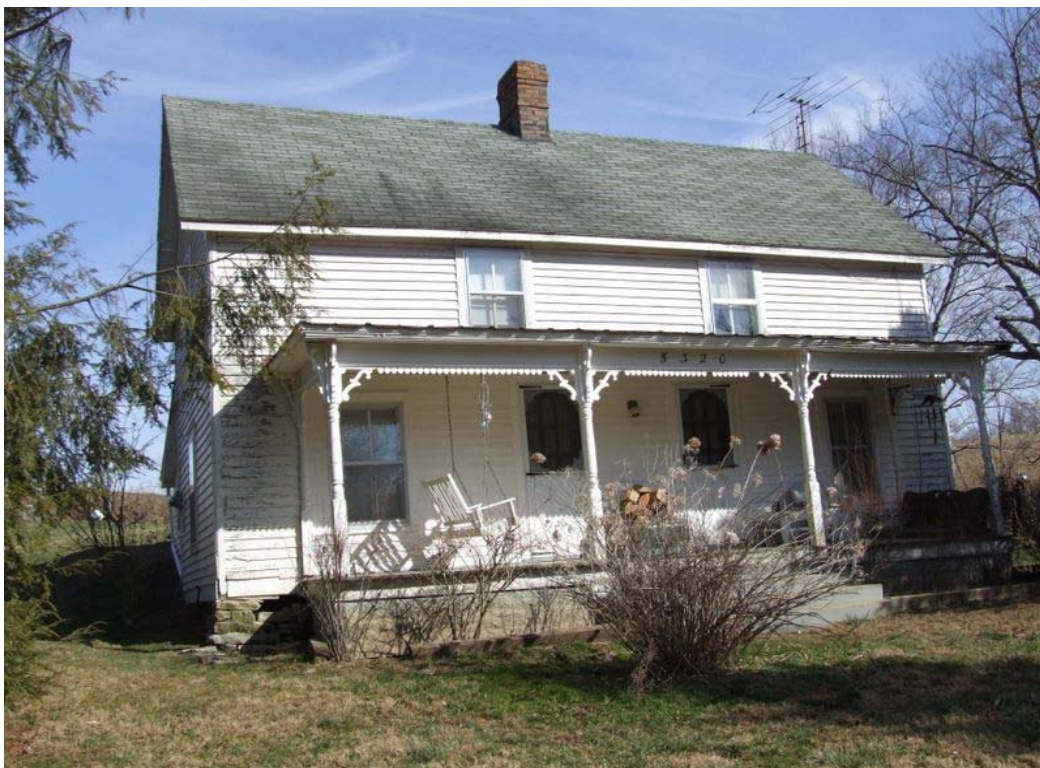
Figure 2: *WS 476, Main House, early twentieth century, Mackville vicinity. See Figure 3 for a site plan of the property.*

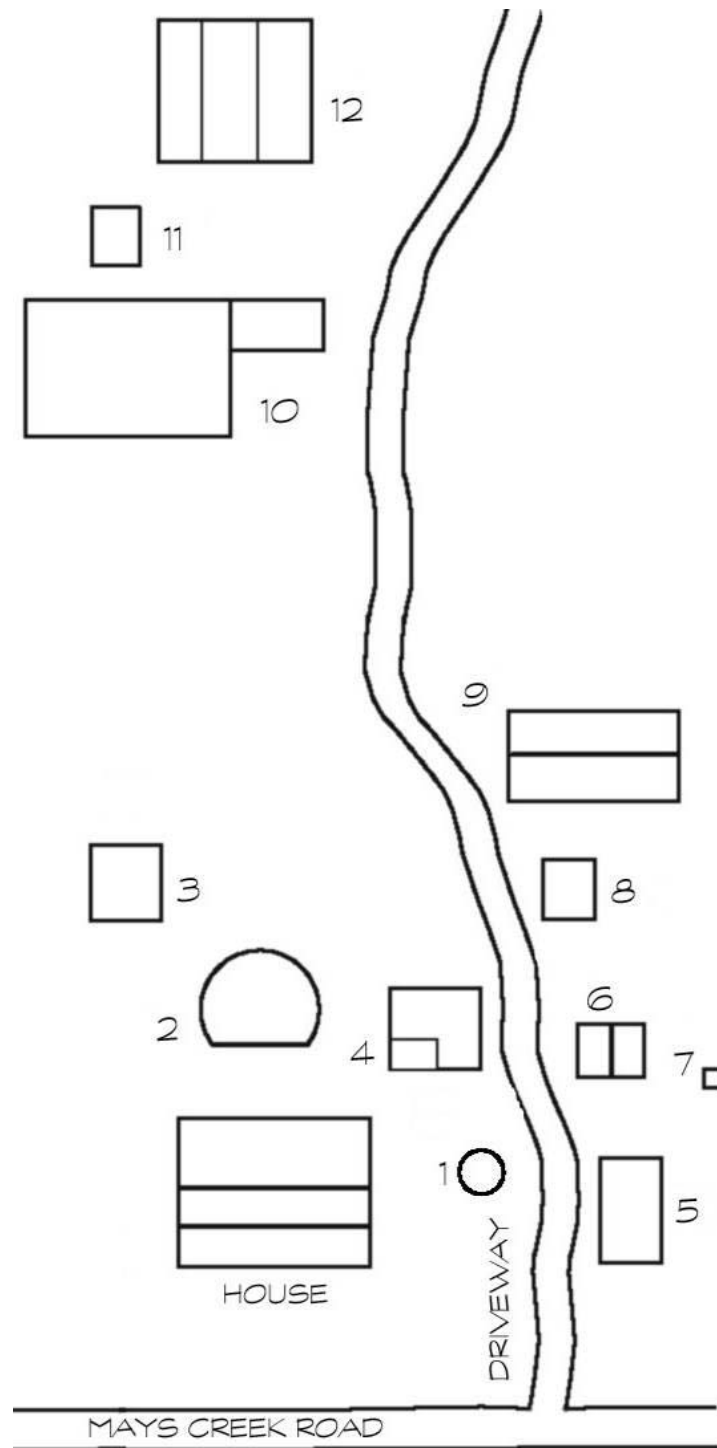
Figure 3: *WS 476, Site Plan. House (Figure 2), 1) Well (Figure 231), 2) Cellar (Figure 191), 3) Brooder House (Figure 4), 4) Meathouse (Figure 209), 5) Garage (Figure 224), 6) Shed or Shop (Figure 216), 7) Privy (Figure 185), 8) Granary (Figure 310), 9) Stable (Figure 265), 10) Tobacco Barn with Stripping Shed (Figure 286), 11) Poultry House (Figure 292), 12) Multi-purpose Stock/Tobacco Barn (Figure 260). Domestic outbuildings cluster around the house and agricultural outbuildings are set some distance away. (Illustration Bill Macintire, based on field notes by Danae Peckler and Jenn Ryall, 1/30/2007).*

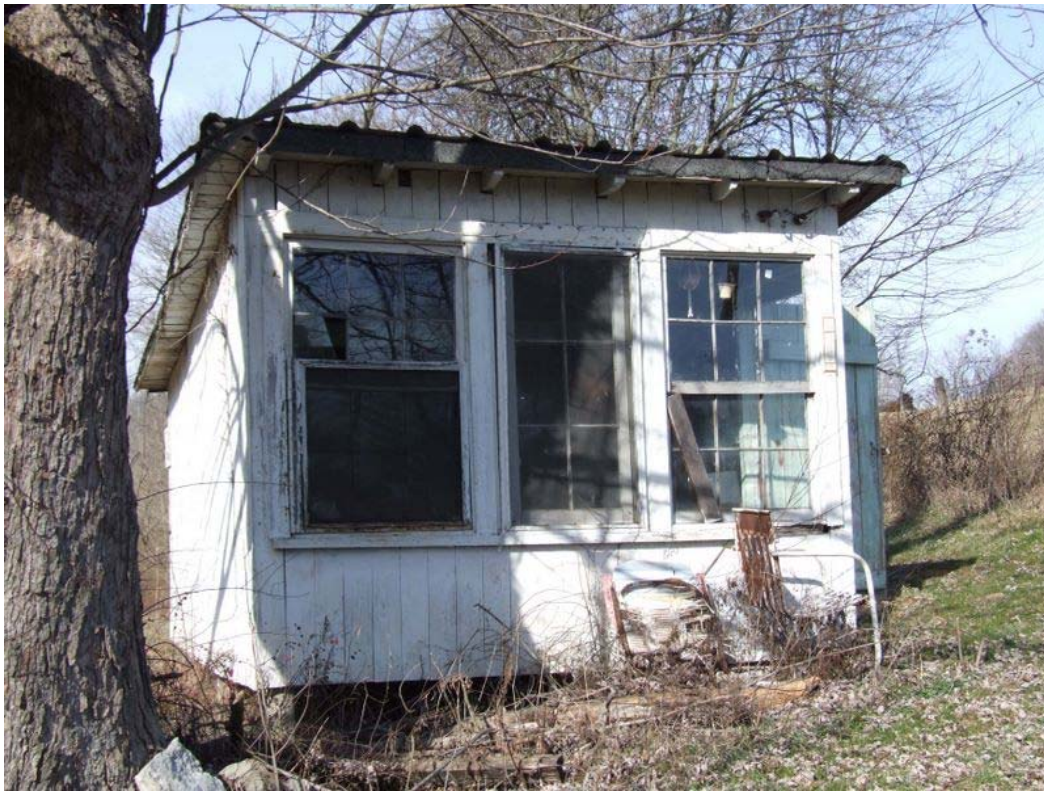
Figure 4: *WS 476, Brooder House, mid-twentieth century, Mackville vicinity.*

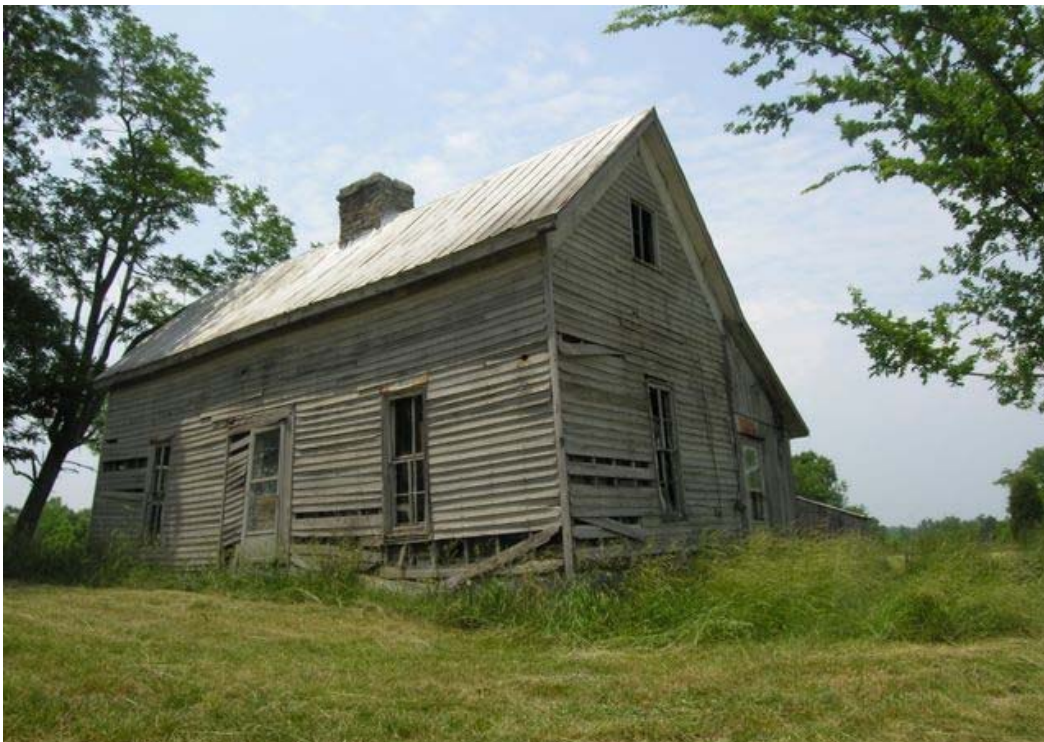
Figure 5: WS 972, Cooksey House, central chimney double pen, mid-late nineteenth century, Willisburg vicinity. The resource itself is a document of the past.

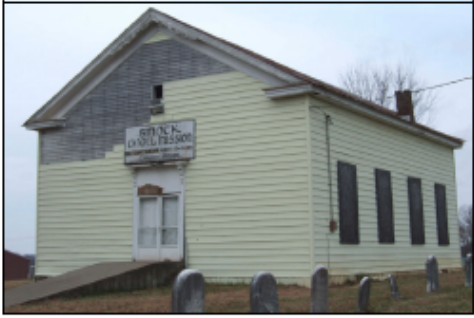
1. NAME OF RESOURCE (how determined): 5 Smock's Methodist Chapel				19. FOUNDATION: <table border="1"> <thead> <tr> <th>TYPE</th> <th>MATERIAL</th> <th></th> </tr> </thead> <tbody> <tr> <td>1 piers</td> <td>A cut stone</td> <td>original</td> </tr> <tr> <td>0 unknown/not ap</td> <td>0 unknown/not applicabl</td> <td>replacement</td> </tr> </tbody> </table>				TYPE	MATERIAL		1 piers	A cut stone	original	0 unknown/not ap	0 unknown/not applicabl	replacement
TYPE	MATERIAL															
1 piers	A cut stone	original														
0 unknown/not ap	0 unknown/not applicabl	replacement

4. OWNER/ADDRESS				22. CONDITION: F fair-under maintained												
5. FIELD RECORDER/AFFILIATION Jenn Ryall and Danae Peckler, KHC				23. MODIFICATION: 1 little or no alteration, historic fabric largely intact

10. ORIGINAL PRIMARY FUNCTION: 06A church/religious structure																
11. CURRENT PRIMARY FUNCTION 99V vacant/abandoned				COMMENTS/HISTORICAL INFORMATION: This is the Smock's Methodist Chapel (now Smock's Chapel Mission). This church appears in its current location on the 1877 Beers Map of Washington and Marion Counties. The church was likely built in the mid-to-late 1800s. Evidence for this is also in the building's style. It has both Greek Revival and Gothic Revival elements. Its returned gable ends, front gable roof configuration, and bands of trim in the gables are Greek Revival features. The Gothic Revival feature is the decorative vergeboard on the front façade. The building has a brick chimney to the right side about 2/3 toward the rear of the building. We talked to one man in Marion County who went to school here. There were four windows on the eave ends of the building. The church is associated with a cemetery.

The site number is printed in the upper right hand corner of the survey form. In the case of Smock's Methodist Chapel (Figure 6 - Figure 9) is identified as MN 231. Also in the upper right hand corner is space for an evaluation of National Register eligibility. In the case of Smock's Chapel, the surveyor has put in the letter "D," which is a code for eligible. This is a recommendation made by the field surveyor: official determinations of eligibility are made by the SHPO. There is also a space to note (usually at a date later than the field survey itself) if the resource has been demolished or lost in some way. While the form employed for this survey project is an older version, recently revised, it remains substantially similar to the one employed today.

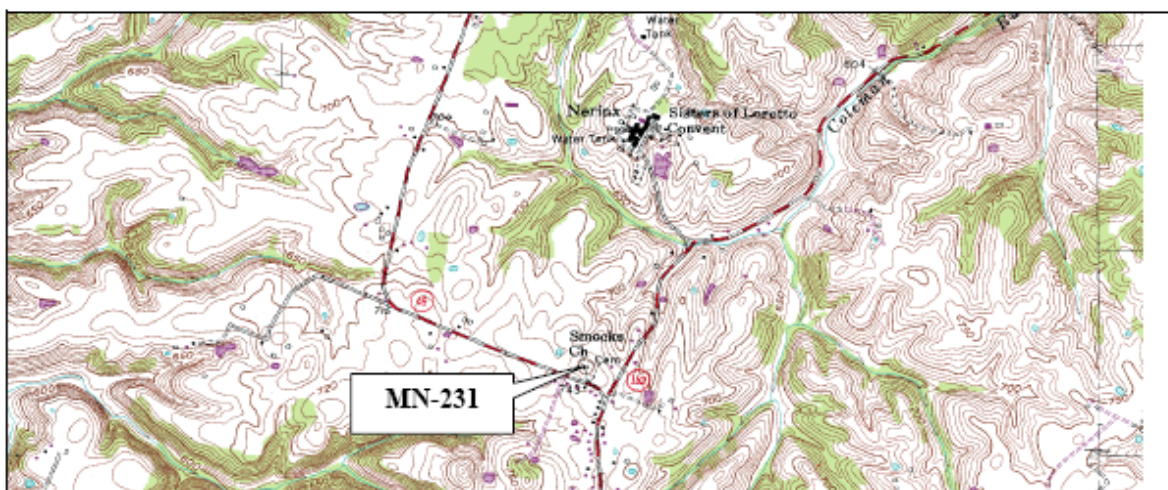
Figure 7: Back of the MN 231 Survey Form. The Site Plan is on a Continuation Sheet, Figure 9.

The back of the form has space for a list of support resources, an annotated site plan, and a map showing the exact location of the site (Figure 7). For the RHDI survey forms, a copy of the site plan from the field notebook is attached on a continuation sheet (Figure 9). Extra photographs and information are found on continuation sheets (Figure 8). Further text, forms for associated resources, pictures, related correspondence, newspaper clippings, or copies of references may be attached to the form as well. Some of this material may be appended at a later date, such as copies of correspondence about the property

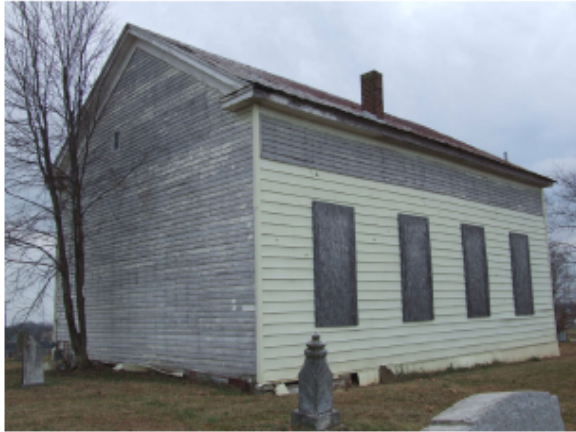
This is a rear/left side photo of Smock's Chapel.

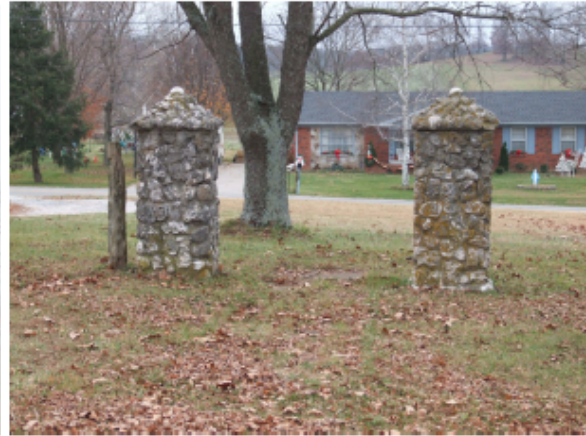
These are the entrance posts (made of coral heads) to Smock's Chapel. They are located to the front.

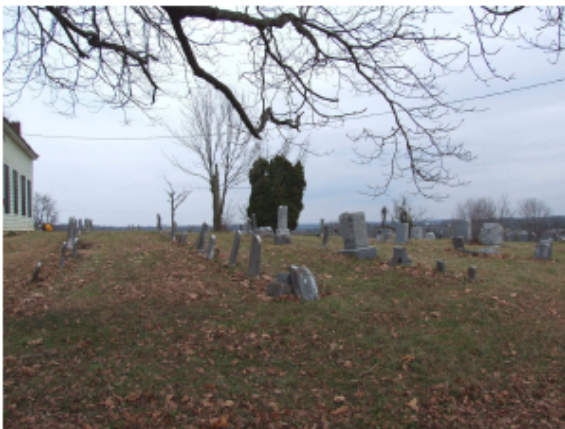
1. This is a photo of the cemetery at Smock's Chapel. It is quite extensive and contains early to mid-19th century graves.

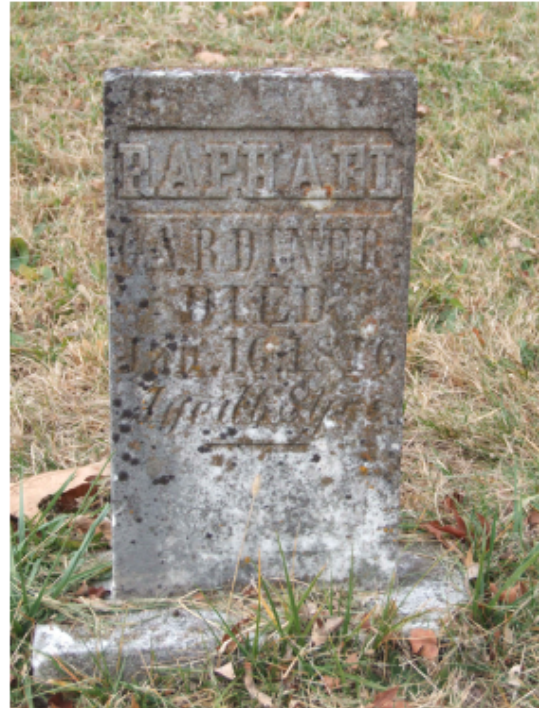
1. This is the oldest gravestone we could find in the cemetery. It appears to read "Raphael Gardiner DIED Jan 16, 1846 . . ."

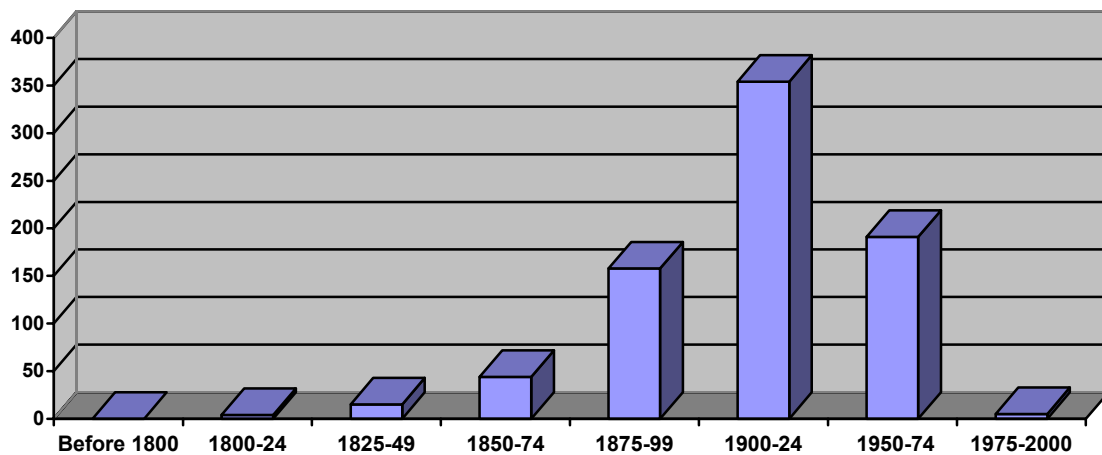
Figure 13: Number of resources documented by date range.
